# 2016 Kumamoto EQ Damage Investigation – Mashiki Town Area

## Preliminary Report

Based on survey carried on May 02, 2016

May 09, 2016

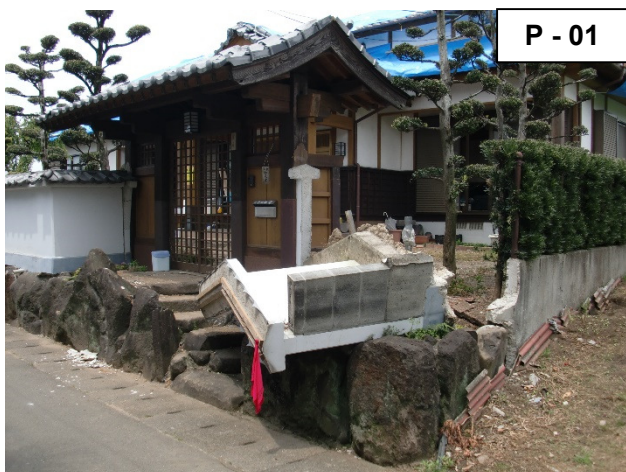
P - 01

The damage observed during the walk through Area I revealed that roof tiles of almost all the old houses fell during the earthquake. Extensive damages to the pillars and walls of the buildings were noted. There were cases of partial or even complete collapse of walls (*see photo, P-01, under subsection 2.1*). The new houses, on the other hand, showed almost no failure except for some shear cracks appearing on the walls (*P-02*). An example of the contrast between the old house and new house were seen adjacent to each other; old house was almost completely damaged while the new house next to the damaged old house showed almost no sign of damage (*P-03, P-05*). One could

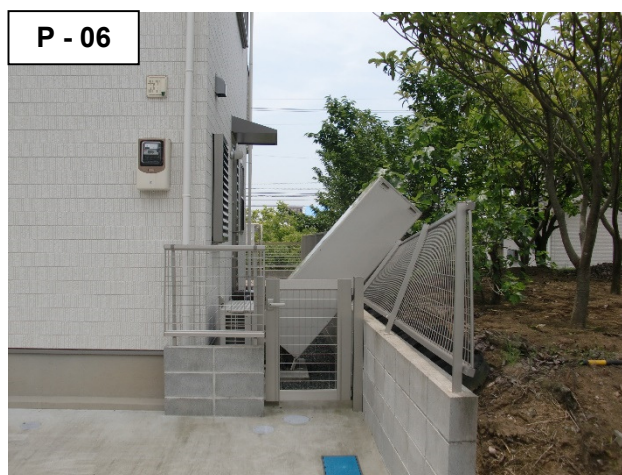
P - 06

argue here that eventually the strength of the building (as a result of aging) played a key factor for the collapse of structures. Also to be noted is that whether it was an old building or a new, outside equipment (such as heating and/or cooling units) were toppled (P-06). Visible failure of roads on some parts due to the movement of sewer/water lines were seen (P-07). A single case of toppling of a huge stone monument was also seen (P-08). Some cases of visible toppling of buildings (in the form of excessive inclination) due to soil movement towards an existing trench was also observed (P-09, P-10, P-11).

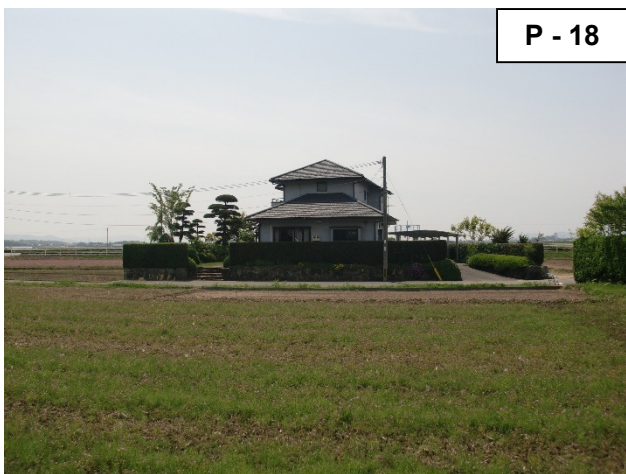
P - 19

Surveyed locations defined under Area II (Figure 1) and reproduced in detail under Figure 4 lies in a plain terrain that is the flood plain, Kasaki (木崎) area being close to the foothill in the south direction. The area lies east of Route 443 and continues to form a part of hilly zone on the south side. In the region between Area I and Area II, damages were seen in the bridge pier (*P-14*) as well as failure of road embankments (*P-15*). The electric poles were also inclined (*P-16*). As in the case of Area I, most of the damage suffered in this region is also by the old houses, barn and sheds. Mostly the failure of first floor was seen (*P-17*). However, isolated (not so new house) was seen without any damage (*P-18*). Houses next to an embankment or trench seemed to suffer the most with the visible soil movement (*P-19*). A case of house with a retaining wall next to a trench and without was seen.

The house without the retaining wall suffered a significant damage due to the movement of foundation towards the trench, while the house with retaining wall showed no damage at all (P-19).

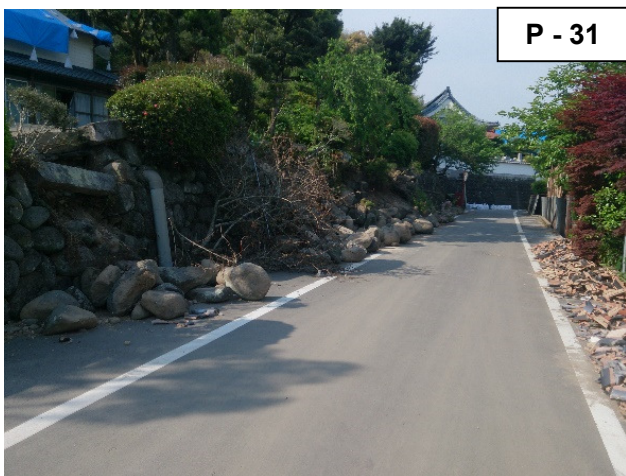
P - 31

Surveyed locations defined under Area IV (Figure 1) and reproduced in detail under Figure 6 lies in hilly region on either side of the Kiyama river (木山川 – see Figure 1) and the last area to be surveyed. Old houses and barns showed damages, while relatively new houses were found to be in good shape, though cracks propagating through the walls could be seen. A surface fault was seen propagating towards east direction (*P-25*, *P-26*, *P-27*) through rice fields (originating in Ishikawa (石川) area and straight through a house (*P-29*, *P-30*), crossing Kaneyamaga river (金山川) in between (*P-28*). The suffered house show a significant damage due to the fault passing through the house. In Tabaru (田原) region, which is located on the hilly terrain on the north side of the flooding plain, old houses were seen with inclination. Collapsed retaining walls were seen (*P-31*).

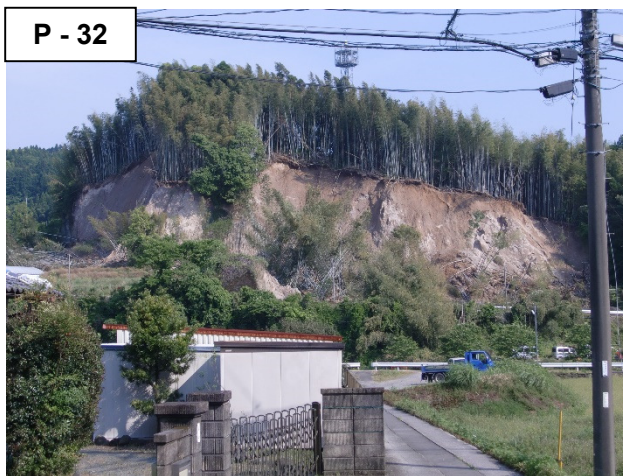
P - 32

As for the Dozono (堂園) region, the area was surveyed from across the river (i.e., from Tabaru (田原)). A massive landside blocking the road could be seen (*P-32*).
