# 2016 Kumamoto EQ Damage Investigation – Mashiki Town Area

## Preliminary Report

Based on survey carried on May 02, 2016

May 09, 2016

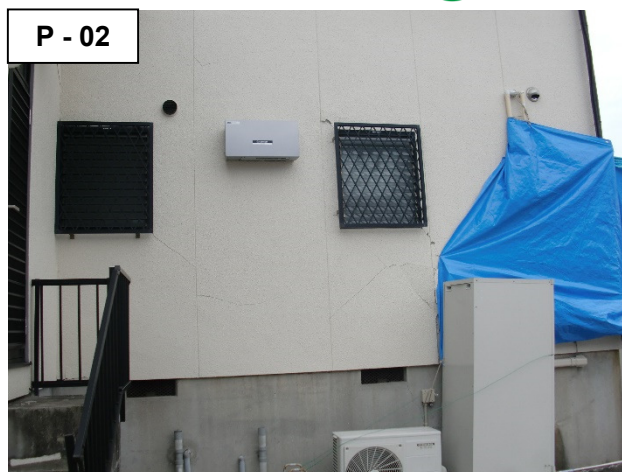
P - 02

The damage observed during the walk through Area I revealed that roof tiles of almost all the old houses fell during the earthquake. Extensive damages to the pillars and walls of the buildings were noted. There were cases of partial or even complete collapse of walls (*see photo, P-01, under subsection 2.1*). The new houses, on the other hand, showed almost no failure except for some shear cracks appearing on the walls (*P-02*). An example of the contrast between the old house and new house were seen adjacent to each other; old house was almost completely damaged while the new house next to the damaged old house showed almost no sign of damage (*P-03, P-05*). One could

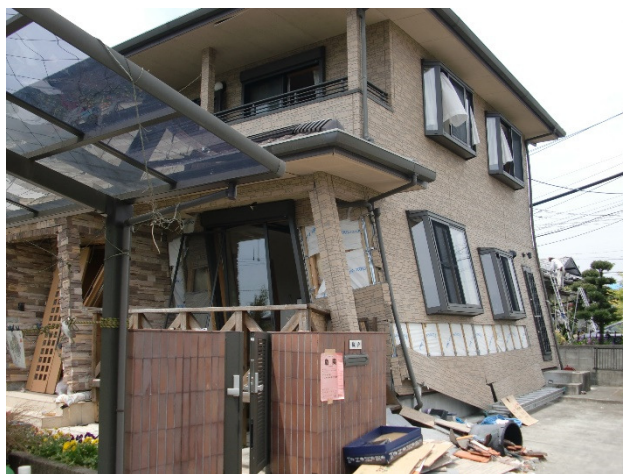
P - 09

argue here that eventually the strength of the building (as a result of aging) played a key factor for the collapse of structures. Also to be noted is that whether it was an old building or a new, outside equipment (such as heating and/or cooling units) were toppled (P-06). Visible failure of roads on some parts due to the movement of sewer/water lines were seen (P-07). A single case of toppling of a huge stone monument was also seen (P-08). Some cases of visible toppling of buildings (in the form of excessive inclination) due to soil movement towards an existing trench was also observed (P-09, P-10, P-11).

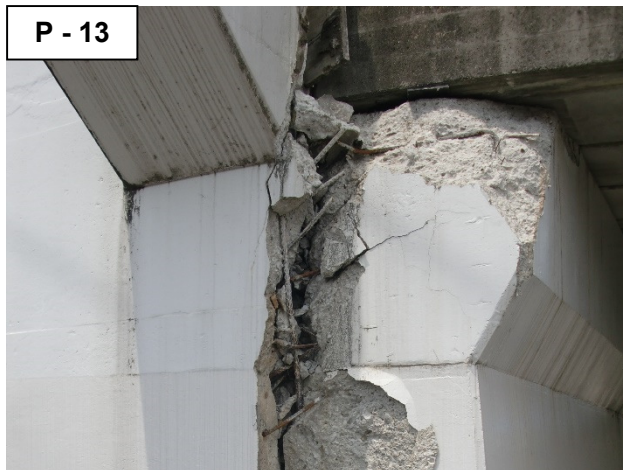
P - 13

Moreover, a case of bridge pier failure was observed, though the vehicle were allowed on the bridge (P-13).

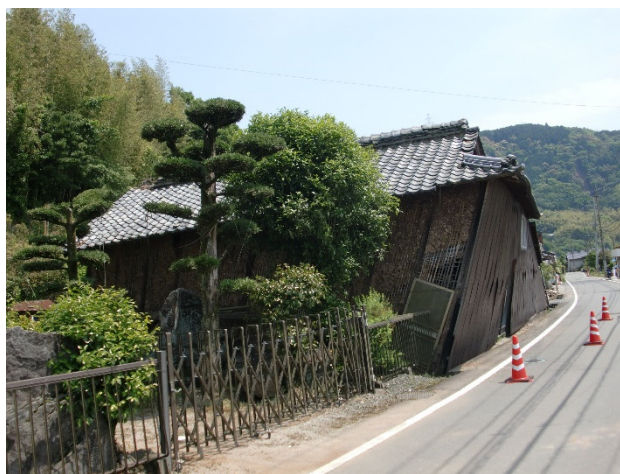
P - 19

Surveyed locations defined under Area II (Figure 1) and reproduced in detail under Figure 4 lies in a plain terrain that is the flood plain, Kasaki (木崎) area being close to the foothill in the south direction. The area lies east of Route 443 and continues to form a part of hilly zone on the south side. In the region between Area I and Area II, damages were seen in the bridge pier (*P-14*) as well as failure of road embankments (*P-15*). The electric poles were also inclined (*P-16*). As in the case of Area I, most of the damage suffered in this region is also by the old houses, barn and sheds. Mostly the failure of first floor was seen (*P-17*). However, isolated (not so new house) was seen without any damage (*P-18*). Houses next to an embankment or trench seemed to suffer the most with the visible soil movement (*P-19*). A case of house with a retaining wall next to a trench and without was seen.

The house without the retaining wall suffered a significant damage due to the movement of foundation towards the trench, while the house with retaining wall showed no damage at all (P-19).

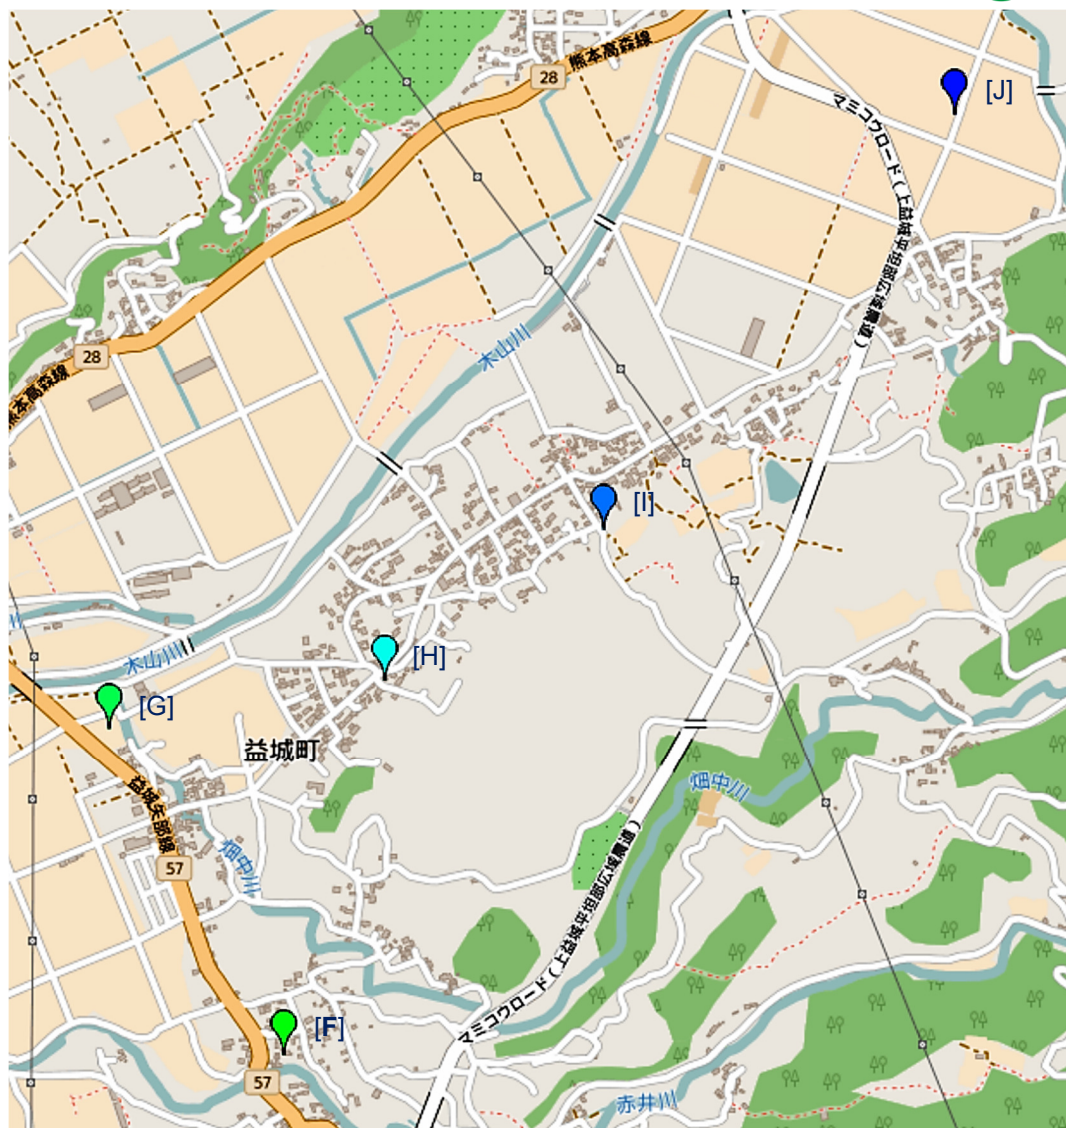
Figure 5: Detailed map of Area III (Openstreet – Scale 1:14,000)

Surveyed locations defined under Area III (Figure 1) and reproduced in detail under Figure 5 lies in a flood plain and runs approximately parallel to the Kiyama river (木山川 – see Figure 5). The alluvial deposits extends towards the south-west side up to the bottom of the hill. The area comprises of both the old settlement, with old and some newly built houses, and a completely new settlement. The old houses in these area suffered inclinations, roof failure, and in some cases the failure of ground floor. The new residential area in this area, on the other hand, shows almost no sign of damage at all (*P-20*, *P-21*, *P-22*), once again showing that strength of structures might be the key. One the other hand, these new buildings are presumed to be built based on new seismic design code, thus, showing higher resistance against earthquake shaking.

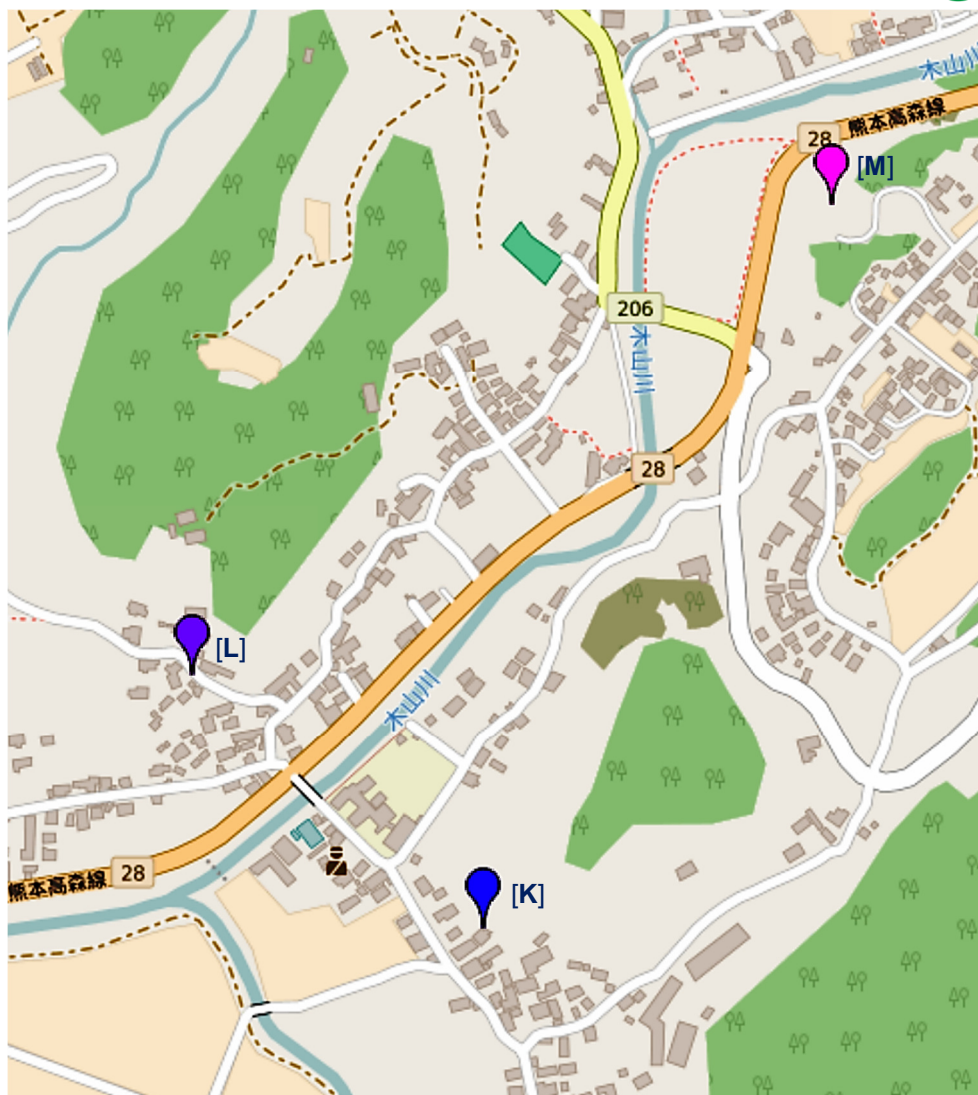
Figure 6: Detailed map of Area IV (Openstreet – Scale 1:8,000)

Surveyed locations defined under Area IV (Figure 1) and reproduced in detail under Figure 6 lies in hilly region on either side of the Kiyama river (木山川 – see Figure 1) and the last area to be surveyed. Old houses and barns showed damages, while relatively new houses were found to be in good shape, though cracks propagating through the walls could be seen. A surface fault was seen propagating towards east direction (*P-25*, *P-26*, *P-27*) through rice fields (originating in Ishikawa (石川) area and straight through a house (*P-29*, *P-30*), crossing Kaneyamaga river (金山川) in between (*P-28*). The suffered house show a significant damage due to the fault passing through the house. In Tabaru (田原) region, which is located on the hilly terrain on the north side of the flooding plain, old houses were seen with inclination. Collapsed retaining walls were seen (*P-31*).

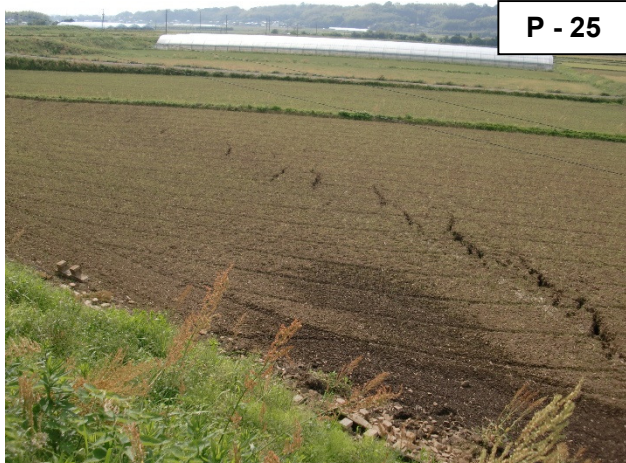
P - 25

A short section of distinct surface fault was visible both crossing the rice field (*P-23*) and a road (*P-24*). Additionally, complete collapse of a concrete bridge over the Kiyama river (木山川) was also seen (*P-25*). Vertical cracks was also seen on the surface of embankment.
